Nanolime consolidation of the main building stone of the archaeological site of Volubilis (Morocco)

Dalal Badreddine, Kévin Beck, Xavier Brunetaud, Ali Chaaba, Muzahim Al-Mukhtar

Dalal Badreddine, Kévin Beck, Xavier Brunetaud, Ali Chaaba, Muzahim Al-Mukhtar. Nanolime consolidation of the main building stone of the archaeological site of Volubilis (Morocco). *Journal of Cultural Heritage*, 2020, 10.1016/j.culher.2019.12.006 . hal-02476671

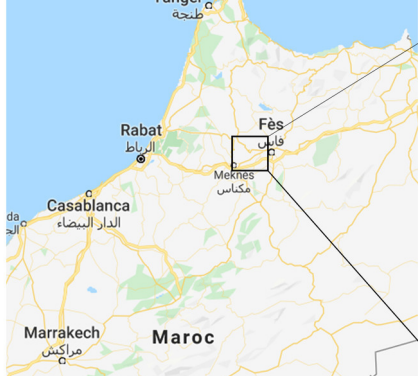
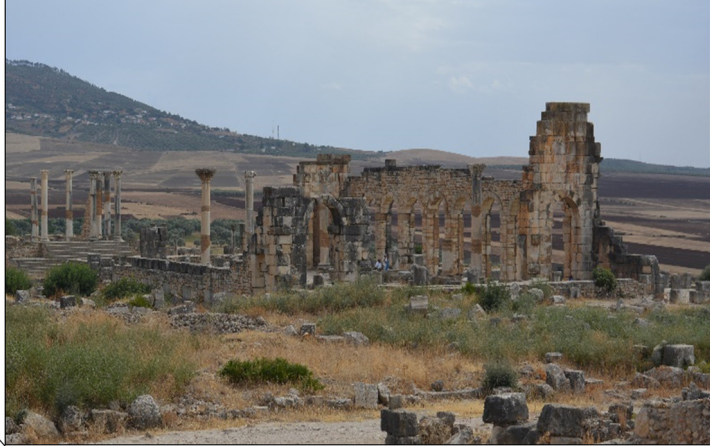
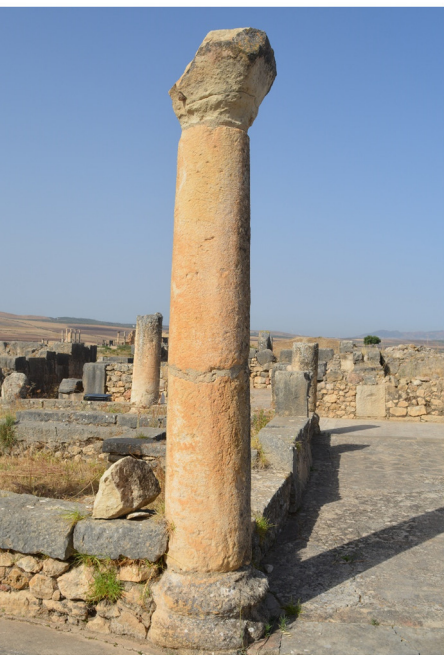
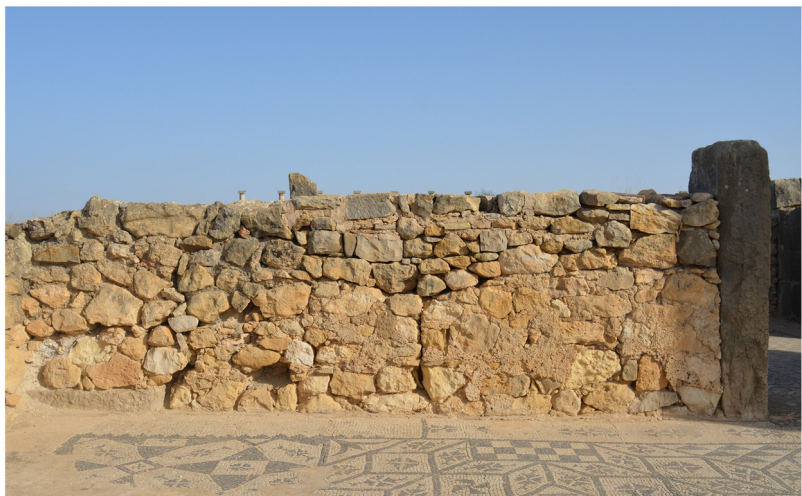
Figure 1: (a) Geographical location of the archeological site of Volubilis, (b) calcarenite stone used as wall rubble and (c) as carved architectural elements

The main objective of this research was to study the efficiency of nanolime as a consolidation treatment of a weathered limestone called calcarenite. Calcarenite is the main building stone of the archeological site of Volubilis, a world heritage site [1] located 30 km north of Meknes city in Morocco (figure 1).

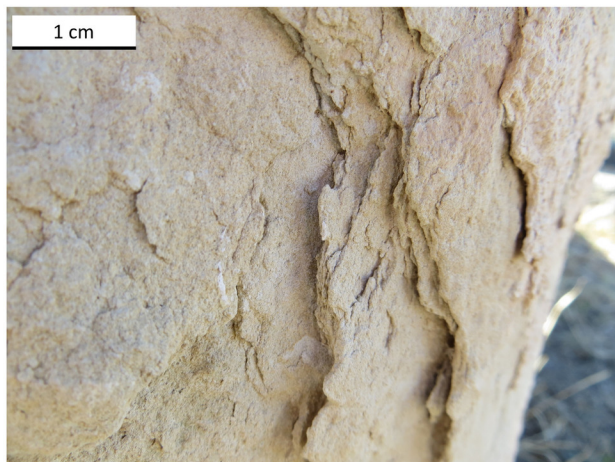
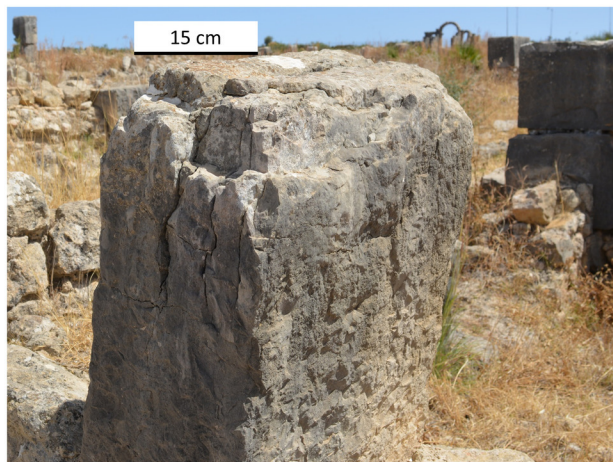
Figure 2: Degradation patterns on the site of Volubilis

Over the years, exposure to aggressive environmental conditions has caused substantial damage to the site's monuments. The damage has affected the site on two levels: structural disorders that occurred after the Lisbon earthquake in 1755 [2], which caused the collapse of most of the monuments, and disorders that affect the building materials (stones and mortar). According to the ICOMOS glossary-illustrated figures of alterations of the stone [3], the degradation patterns observed in situ can be divided into two categories: biological colonization that alters the aesthetic aspect of the stone and degradation patterns that cause a loss of matter. The latter includes sanding, scaling and alveolization that are due to the crystallization of destructive salts originated in some of the restoration mortars and transported to the stone porosity by water transfer [4], as well as cracking that is caused by climatic variations [5].

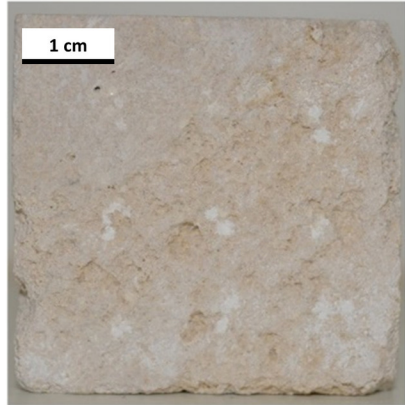
Figure 10: Calcarenite stone sample ($4\times 4\times 4\text{ cm}^3$) (a) before, (b) after the second salt crystallization test and (c) after treatment with nanolime

The salt crystallization aging test caused a decrease in the L* coordinates and an increase in the a* and b* coordinates. This means that the samples were darker, redder and more yellow. After the treatment, an increase in the L* value for all the samples was noticed, which implies a lightening of all the samples that was due to the white haze observed on the surface of the stones, as a part of the nanolime absorbed had actually settled on the surface (figure 10).
